**SINCLAIR ZX SPECTRUM  
 CIRCUIT DIAGRAM  
 ISSUE 1**  
 ORIGINALLY DRAWN - JULY 1983  
 BY ADRIAN C. DICKENS  
 REMASTERED & UPDATED - OCTOBER 2023  
 BY GAVIN STEADMAN BRIGGS  
 WITH THANKS TO MARK SMITH FOR HIS ASSISTANCE  
 Version 2.0

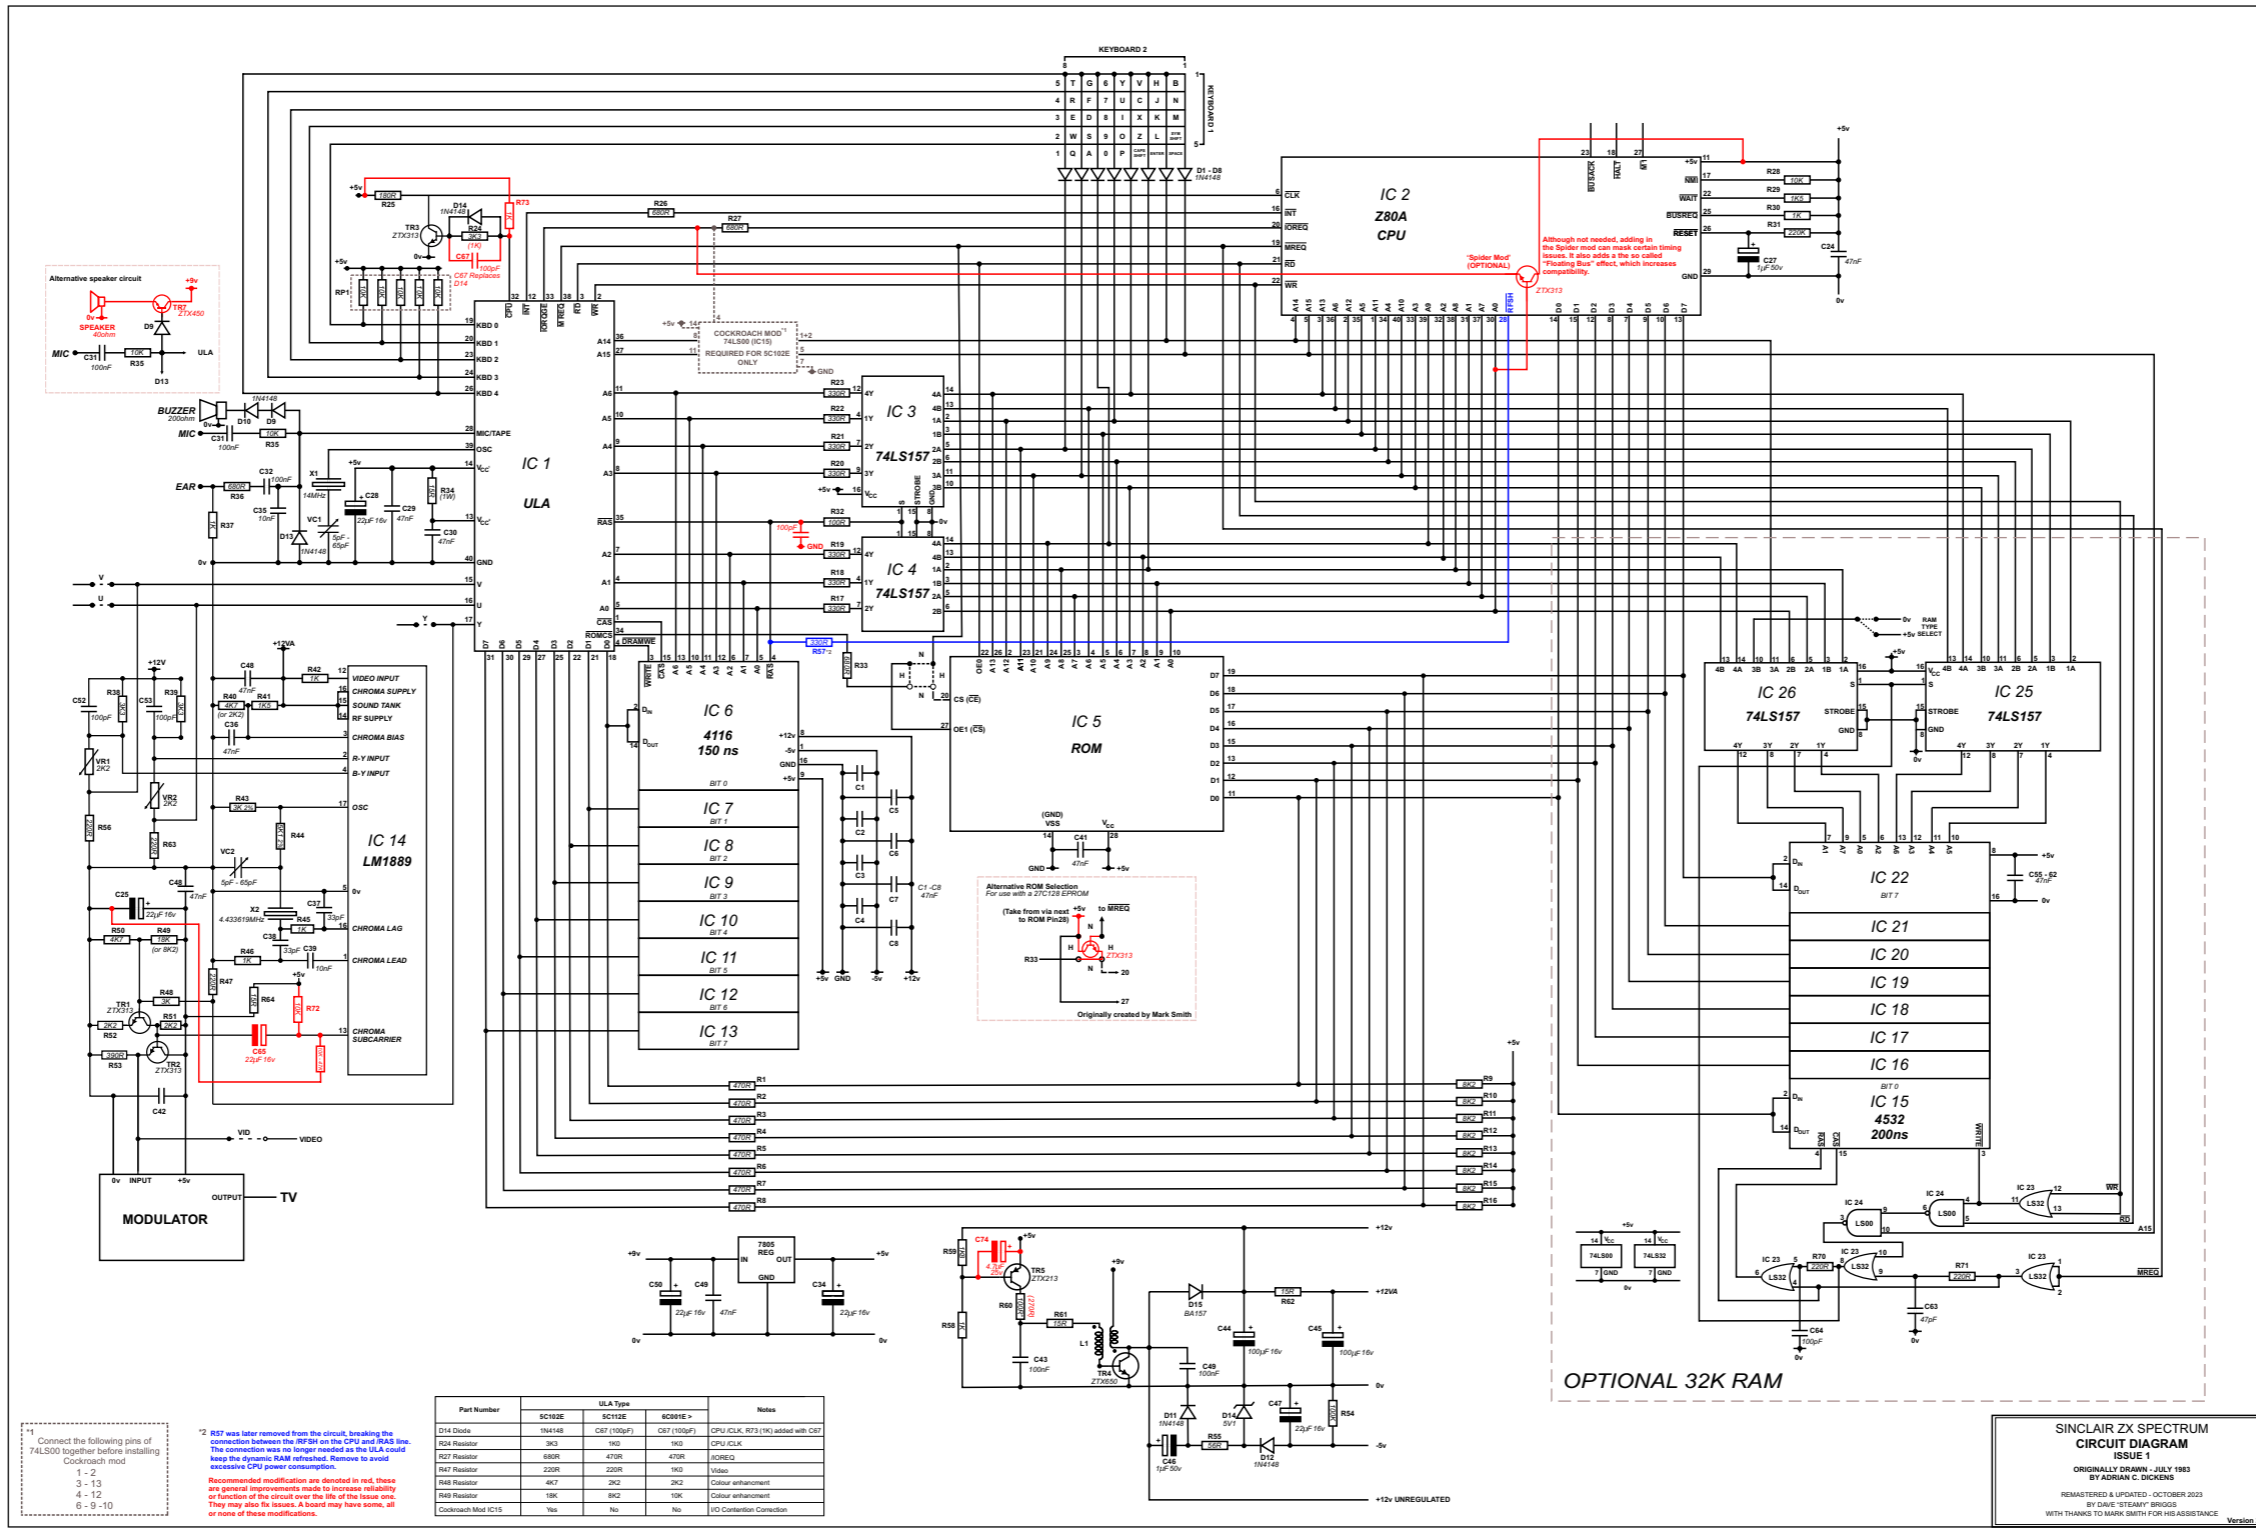
\*1 Connect the following pins of 74LS00 together before installing Cockroach mod  
 1 - 2  
 3 - 13  
 4 - 12  
 6 - 9-10

\*2 R27 was later removed from the circuit, breaking the connection between the BP 26 on the CPU and R26 on the ULA. This connection was no longer needed as the ULA could keep the optional RAM operational. Remove to avoid excessive CPU power consumption.  
 Recommended modification are denoted in red, these are general improvements made to increase reliability or function of the circuit over the life of the issue one. They may also fix issues. A board may have some, all or none of these modifications.

Part Number	ULA Type	Notes
D14 Diode	SC102E	CPU CLK, R73 (R) added with C67
R24 Resistor	3K	CPU CLK
R27 Resistor	500K	470K
R47 Resistor	220R	150K
R48 Resistor	4K7	2K2
R49 Resistor	18K	82K
Cockroach Mod IC15	Yes	No
